## BG Frigi-Clean® Service on '96 and newer Grand Prix

December 12, 2002 || 02-154

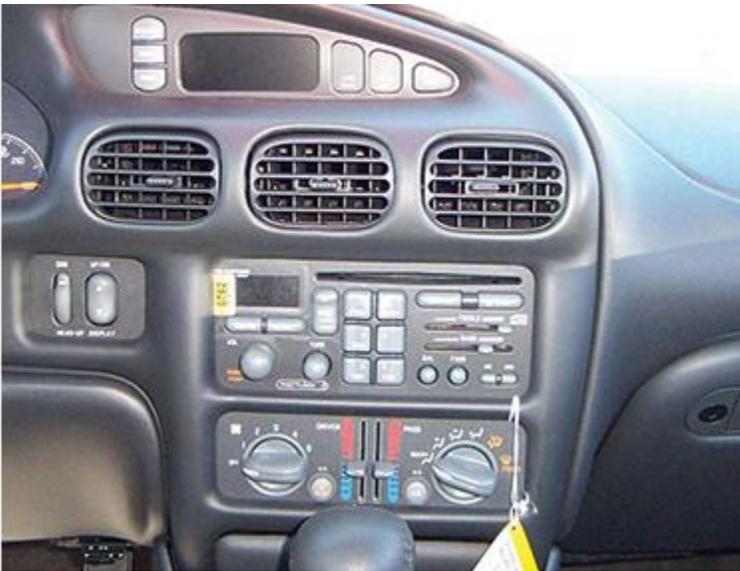
This is where the problem occurs with the Grand Prix. The BG Frigi-Clean that was pushed through the evaporator is blown as a foam through the air ducts and out the vents on top of the radio and A/C and heater controls (see photo). The BG Frigi-Clean then turns from foam back into a liquid. This liquid seeps in and destroys the radio and/or A/C and heater controls.

The BG Frigi-Clean Service can be done on this particular vehicle if caution is taken. Only inject half of the contents of one can of BG Frigi-Clean in the evaporator box. Let it sit for the 10 minute soak period and then start the vehicle with A/C blower turned on “High.” If there is any product coming towards the vents above the radio and A/C and heater controls, turn the blower off. The product will drain out of a drain hole in the evaporator case eliminating any problems.
