## Home Inspection Report

123 Happy Street, Colorado Springs, CO 80918

Wednesday, October 17, 2018

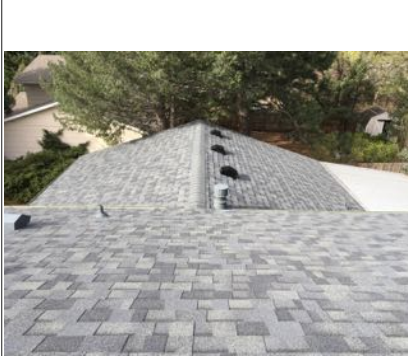
General roof view.

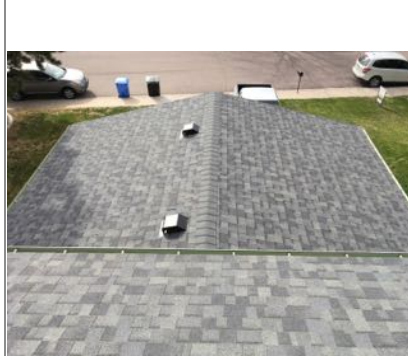
General roof view.

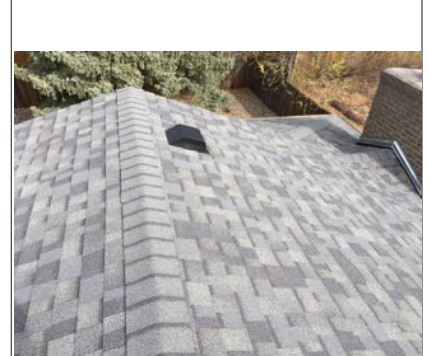
General roof view.

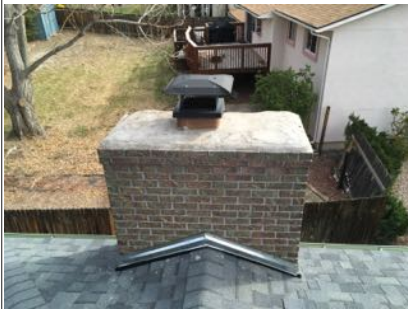
The chimney.

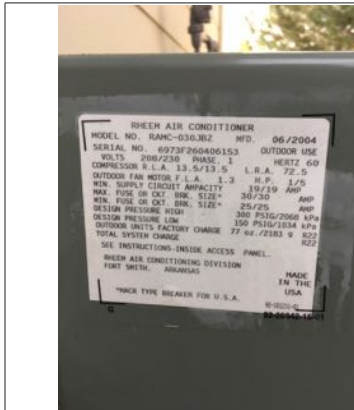
The air conditioner compressor/condenser data plate.

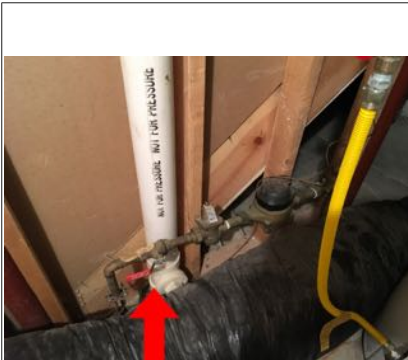
The main water shutoff.

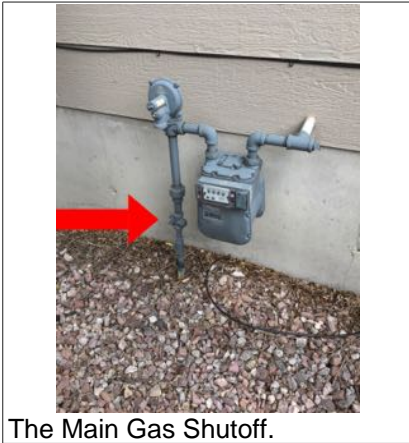
The Main Gas Shutoff.

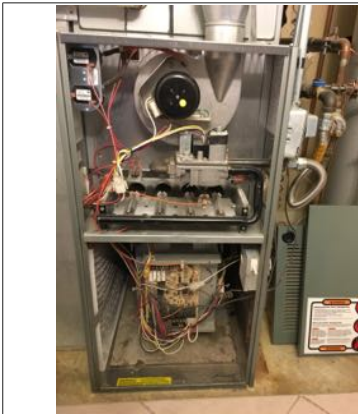
**Comments** The average life expectancy for a gas fired forced air system is 15-25 years. Recommend budgeting for replacement.

The furnace, cover off.

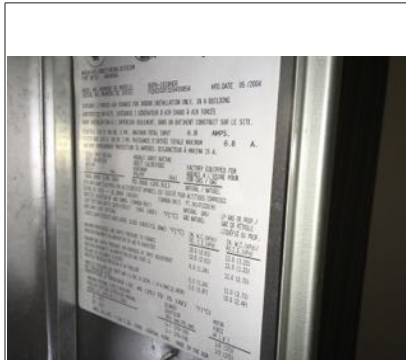
The furnace data plate.
